Contract #: 04-0120F4Cty: SF/ALA Rte: 80 PM: 13.2/13.9File #: 82.28**WELDING INSPECTION REPORT****Resident Engineer:** Siegenthaler, Peter**Address:** 333 Burma Road**City:** Oakland, CA 94607**Report No:** WIR-026205**Date Inspected:** 18-Aug-2011**Project Name:** SAS Superstructure**OSM Arrival Time:** 630**Prime Contractor:** American Bridge/Fluor Enterprises, a JV**OSM Departure Time:** 1500**Contractor:** Westmont Industries**Location:** Santa Fe Springs, CA**CWI Name:** Ruben Dominguez**CWI Present:** Yes No**Inspected CWI report:** Yes No N/A**Rod Oven in Use:** Yes No N/A**Electrode to specification:** Yes No N/A**Weld Procedures Followed:** Yes No N/A**Qualified Welders:** Yes No N/A**Verified Joint Fit-up:** Yes No N/A**Approved Drawings:** Yes No N/A**Approved WPS:** Yes No N/A**Delayed / Cancelled:** Yes No N/A**Bridge No:** 34-0006 L & R**Component:** Maintenance Travelers**Summary of Items Observed:**

SAS-WB Traveler – Lower Truss Frame Assembly

E2/E3-WB Traveler (South)

WELDING INSPECTION REPORT

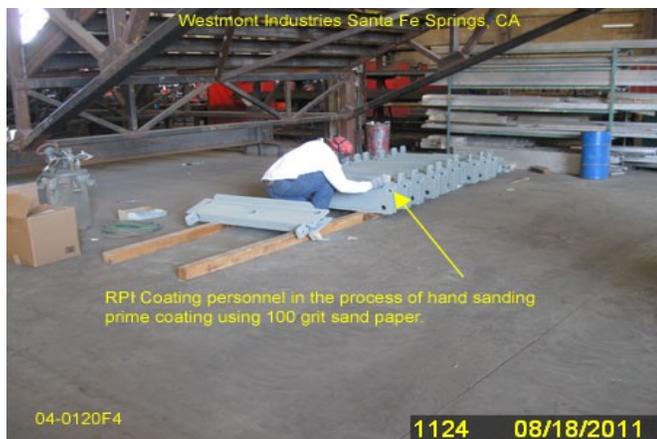
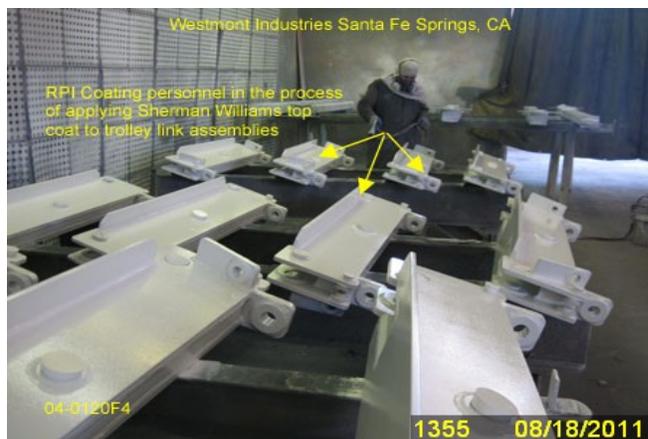
This QA Inspector observed that the activities mentioned above, appeared to be in compliance with the contract requirements and this QA Inspector observed no non-conforming issues, on this date.
